# Consulting Arborist Report Type 1

### **SECTION 3- Photo Documentation**

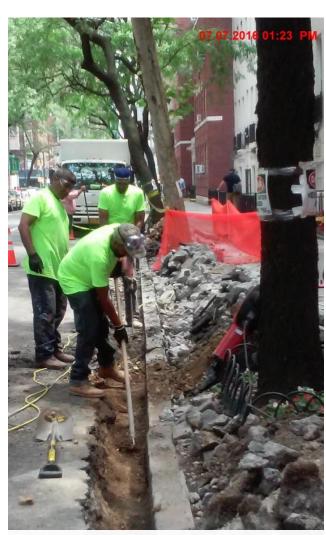
Shown are 4'x 5' bed dimensions before curb & sidewalk work started on July 6, 2016.

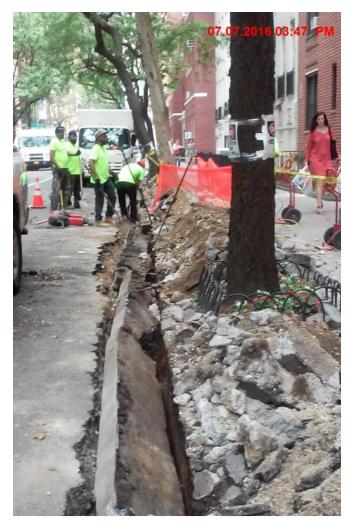
Removal of 18" granite curb required excavation streetside (north) of curb ONLY, as shown. Excavation depth of 24" allowed crew to break then remove northern half of concrete footing

After broken half of footing was removed, the 12' long, 18" granite slabs simply fell northward with a pry bar. Slabs' tight fit /wedged condition and heavy weight facilitated 'dropping' of the curb. After first was pryed out, the rest fell like dominos – peeling away from tree beds and root zones, *cleanly*, in less than an hour of time. (Hats off!)

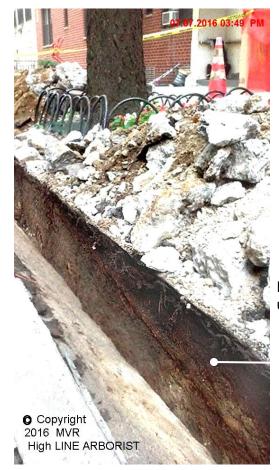
The vertical 'face, or wall of earth, behind the curb <u>was fully intact</u> after prying the curb away from it, <u>as were **all tree roots** growing vigorously right at the face, to strengthen and hold it up. Close-ups on next page.</u>

Exemplary profiles like this of intact tree roots for entire work length was unbelievable, but amazing to see. An accomplishment, by any measure.

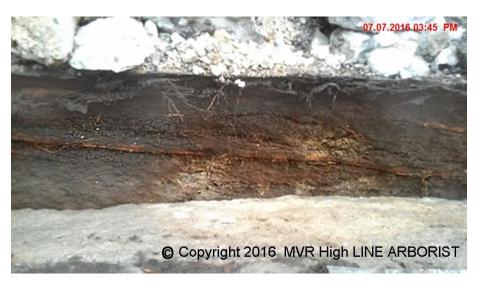
This is sheer vertical soil 'face' left standing after granite slabs dropped away. Note the hefty roots descending from trunk of **Tree 1** Honeylocust.
