Re: 595 W.239<sup>th</sup> St. HM Complex – Inspection/Evaluation of Mature Red Oak Tree

**PDF 2 INSPECTION/EVALUATION RED OAK TREE by MVR CA**  
At 595 W.239<sup>th</sup> St. Hudson Mews Complex Riverdale, NY 5.13.19

**PDF 1** INSPECTION/EVALUATION RED OAK TREE by MVR CA  
At 595 W.239<sup>th</sup> St. Hudson Mews Complex Riverdale, NY

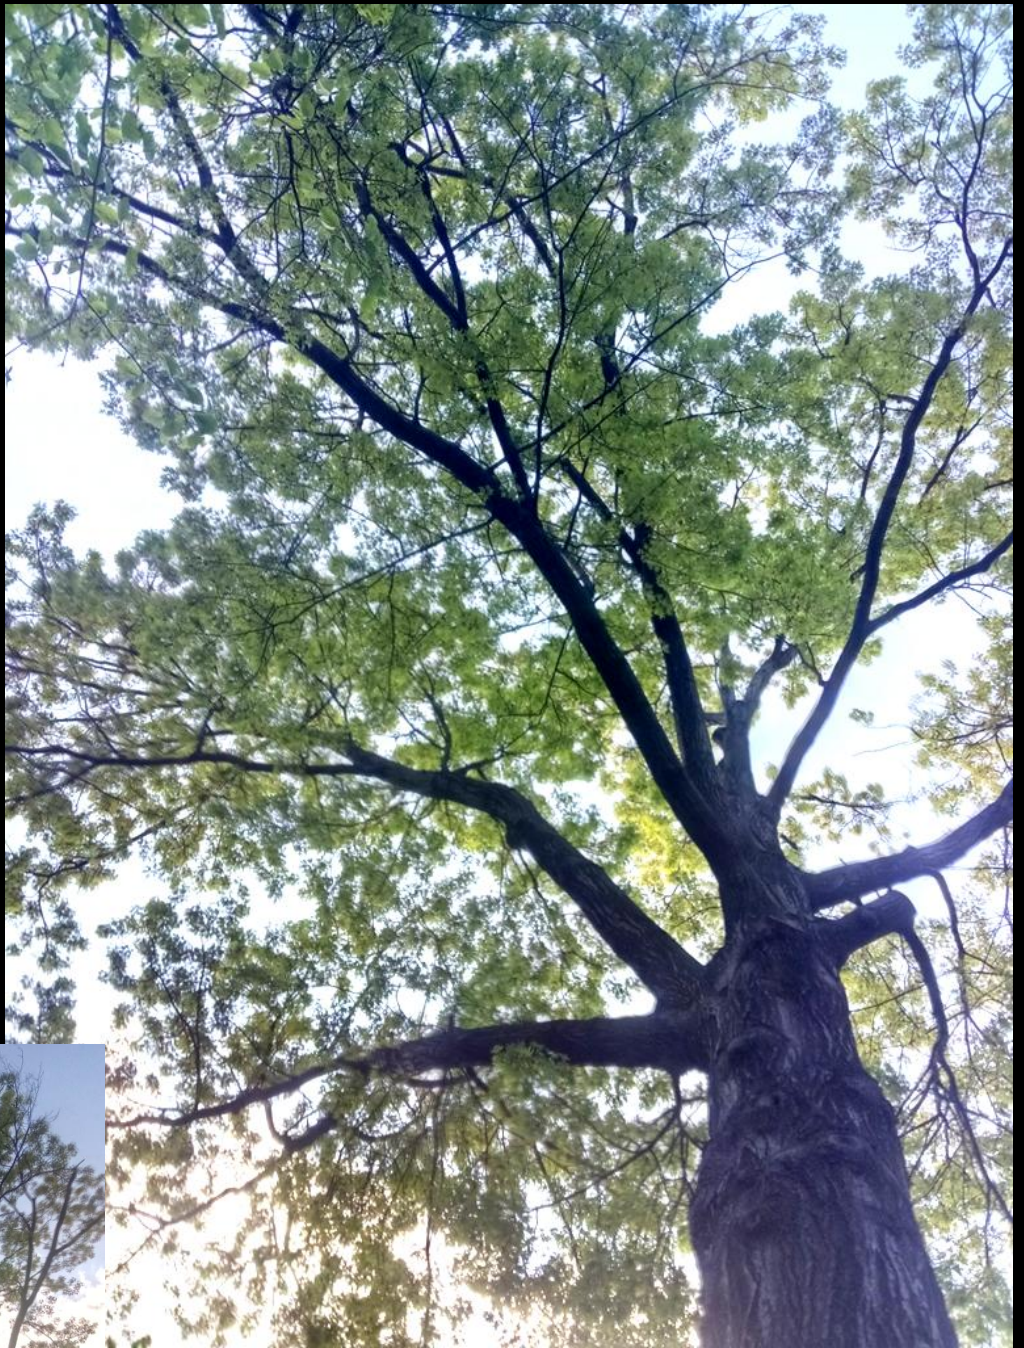
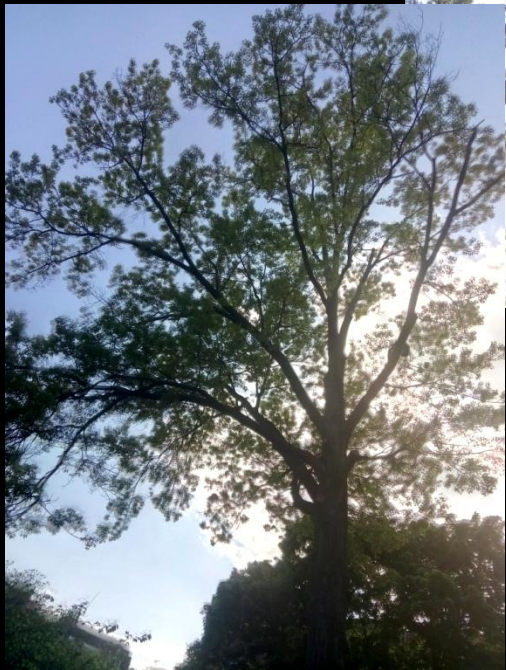
2.1.1

1. Full foliage of all major scaffold and secondary branches throughout the tree's broad canopy, as seen in attached PDF image taken on May 8.
2. The cavity at base of trunk is not sizable enough to substantiate the claim that tree is hollow, unsound structurally, and cause for tree removal. See accompanying PDF 2 for specific data on this cavity.

These Photos taken on May 8, 2019 show foliage of all branches throughout of the entire canopy of this tree. Just a few small branchlets at top of tree had no leaves, which is fairly common.

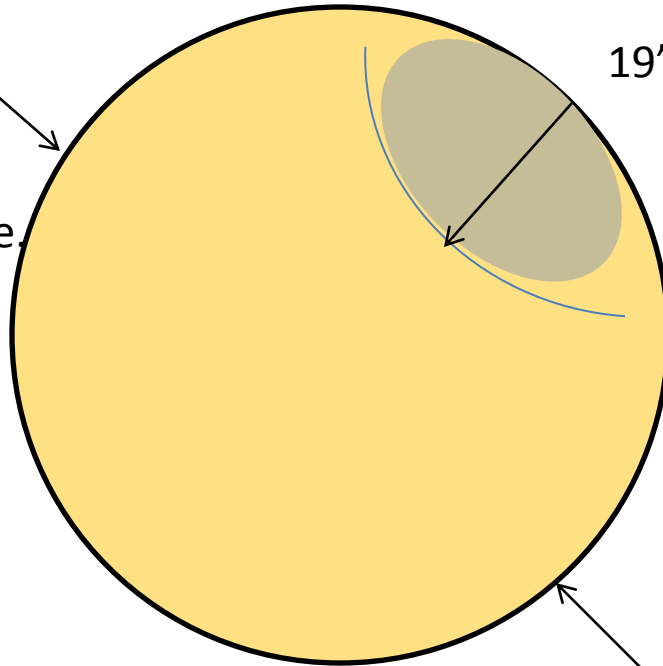
60" diameter at base of trunk

Cavity depth is 1/3 of full trunk, at tree base. Remaining part of trunk is LIVE WOOD. There is little or no physical evidence to purport otherwise.

19" deep cavity

**Top:** Base of trunk analysis **Bottom:** All receptacles to be **relocated**.

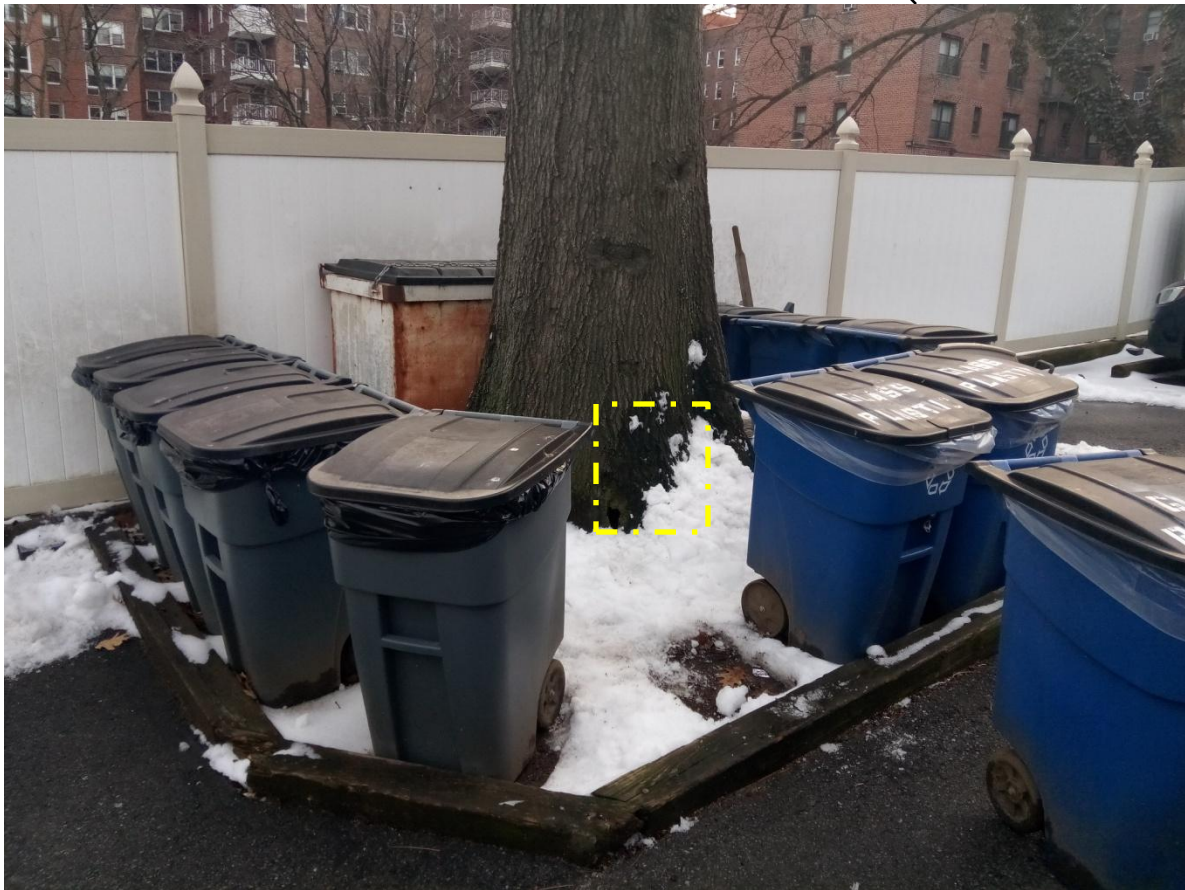
Relocation of all trash receptacles and bins from the exposed/ bare earth root zone of this tree will optimize the health and vigor of the tree. Removal of dumpster helps, but objects remaining still deprive the tree of maximum water and oxygen intake needed to sustain health and vigor on a longstanding basis.

Leaving receptacles without question favors tree decline. On the other hand, making several parking spaces smaller for compact cars -- to free-up space to accommodate trash bins -- is pro-active measure to preserve the invaluable shade and beauty this tree provides.
