September 22, 2022

CONSULTING ARBORIST SERVICES – Tree Condition, Impacts, Appraisal Report

This report presents an analysis of potential impacts by proposed construction activity at 240 W 123rd St NY, NY on 1 White Mulberry tree in rear yard of the adjacent property located at 242 W 123rd St . NY, NY.

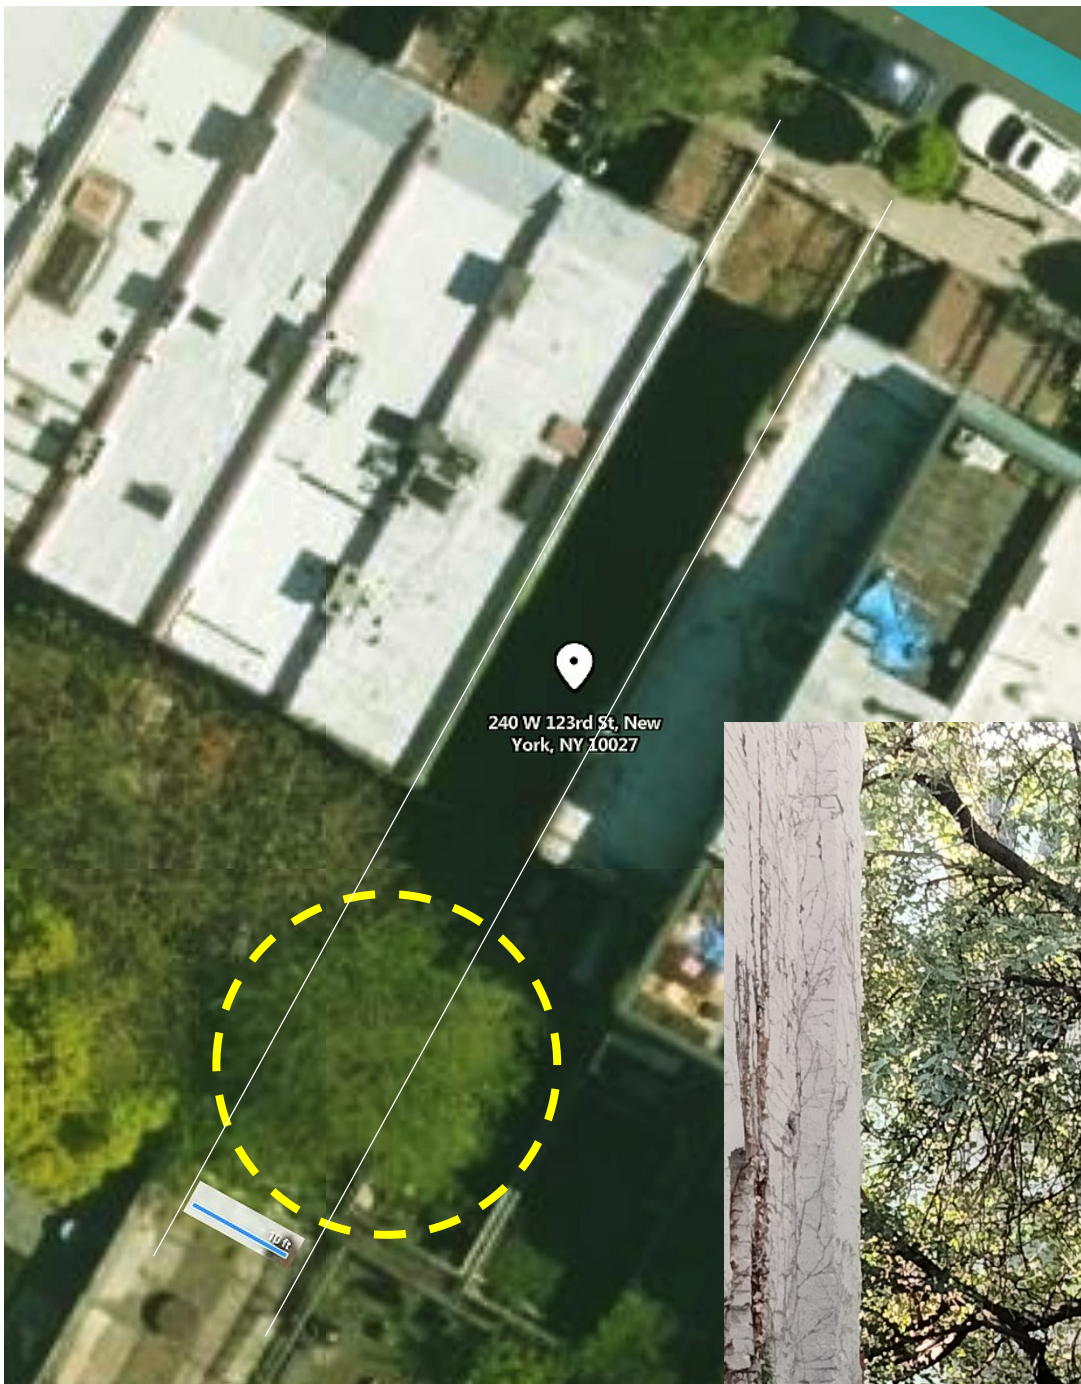
Figure 1

Canopy Lean - Inordinate, dangerous lean greater part of canopy- up to 90%- spans over neighboring parcels of 240 -23 w 123rd St. **Fig 1,2.**

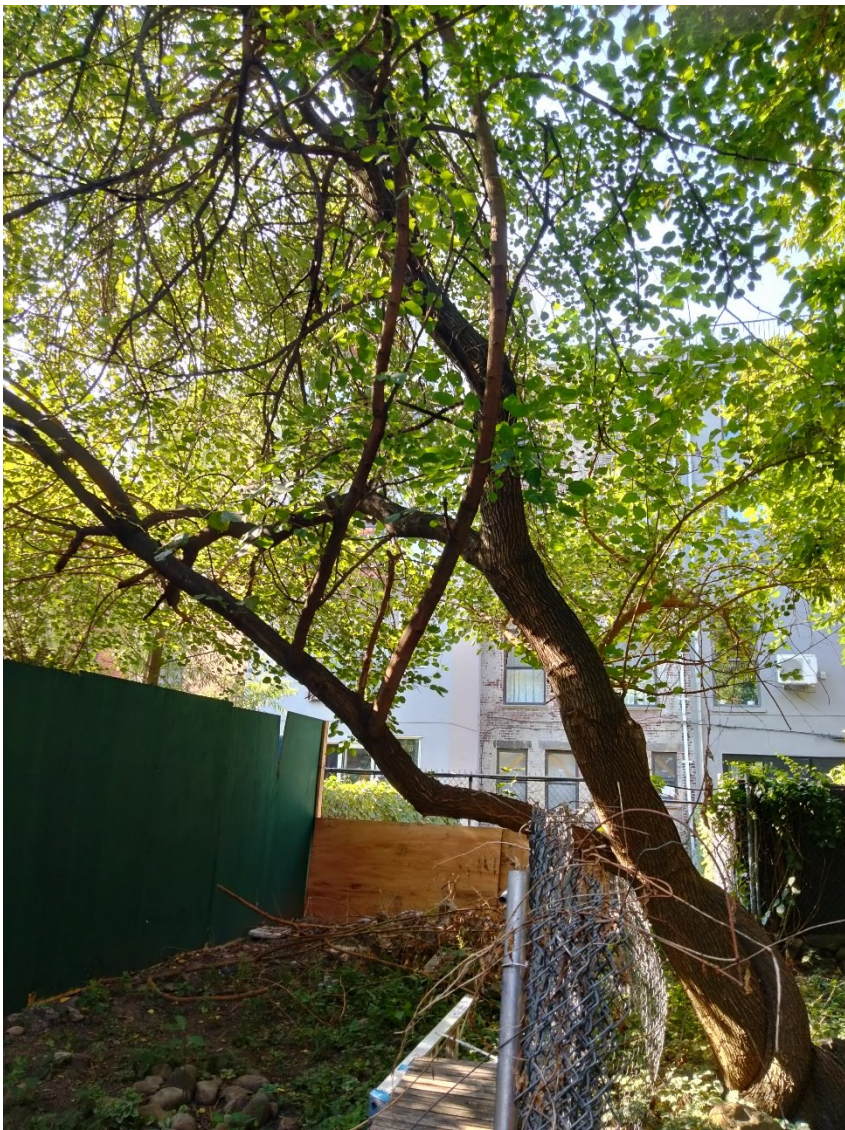
Figure 3

Tree's Location on Site – Tree Trunk is approximately 21" from shared property line. The limit of construction excavation for 240 W. 123 is this shared property line **Fig. 3,4.**

Excavation limit to shared property line would not *just severely encroach into tree's critical root zone but remove at least half of tree's entire root system.* Result would be death of the tree, which would happen somewhat quickly. Decline of the involved tree would be noticed immediately.

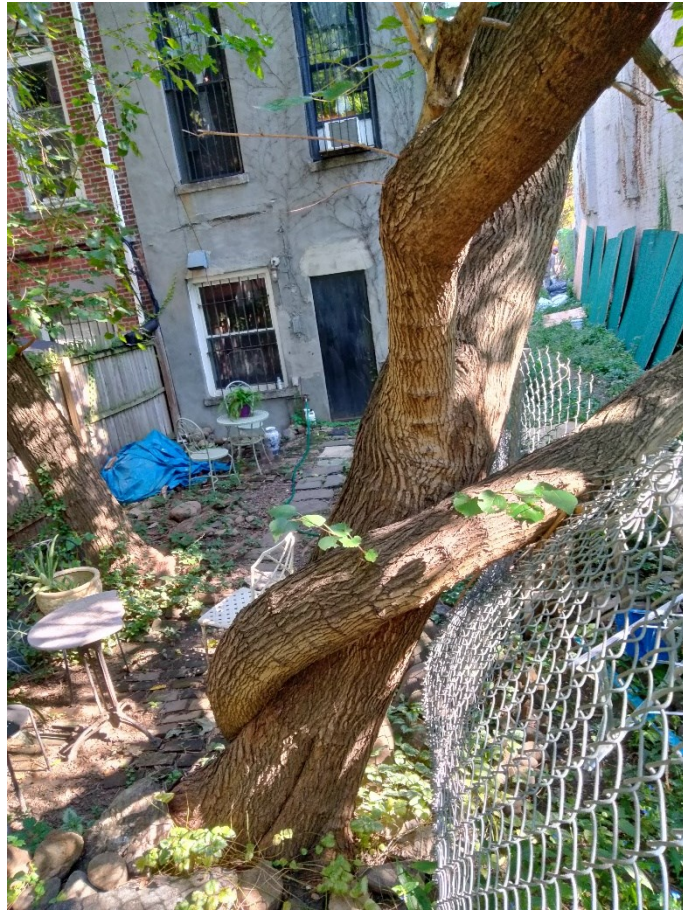
Figure 5

Severe Structural Issues – Tree has severe structural problems, most noticeably with girdling branch (co-stem) that originates at ground level. **Fig 5.** While it may seem fanciful and even charming, it compromises stability of entire tree and would be considered a liability for 242 property owner.

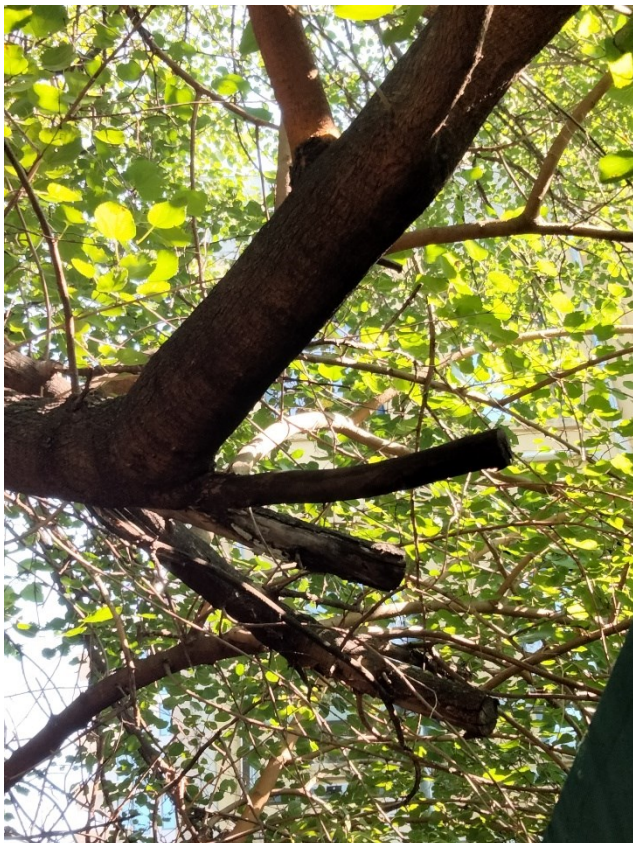
Figure 6

Pronounced Deadwood - Severe, pronounced dieback throughout entire canopy. Preponderant evidence that canopy has been cut back repeatedly by neighboring properties to the east and south. **Fig. 6,7.**
